ICE POND DAM  
NH.00145

PHASE I INSPECTION REPORT  
NATIONAL DAM INSPECTION PROGRAM

APRIL, 1979

Identification No: NH00145  
Name of Dam: Ice Pond Dam  
Town: Littleton  
County and State: Grafton County, New Hampshire  
Stream: Alder Brook  
Date of Inspection: November 14, 1978

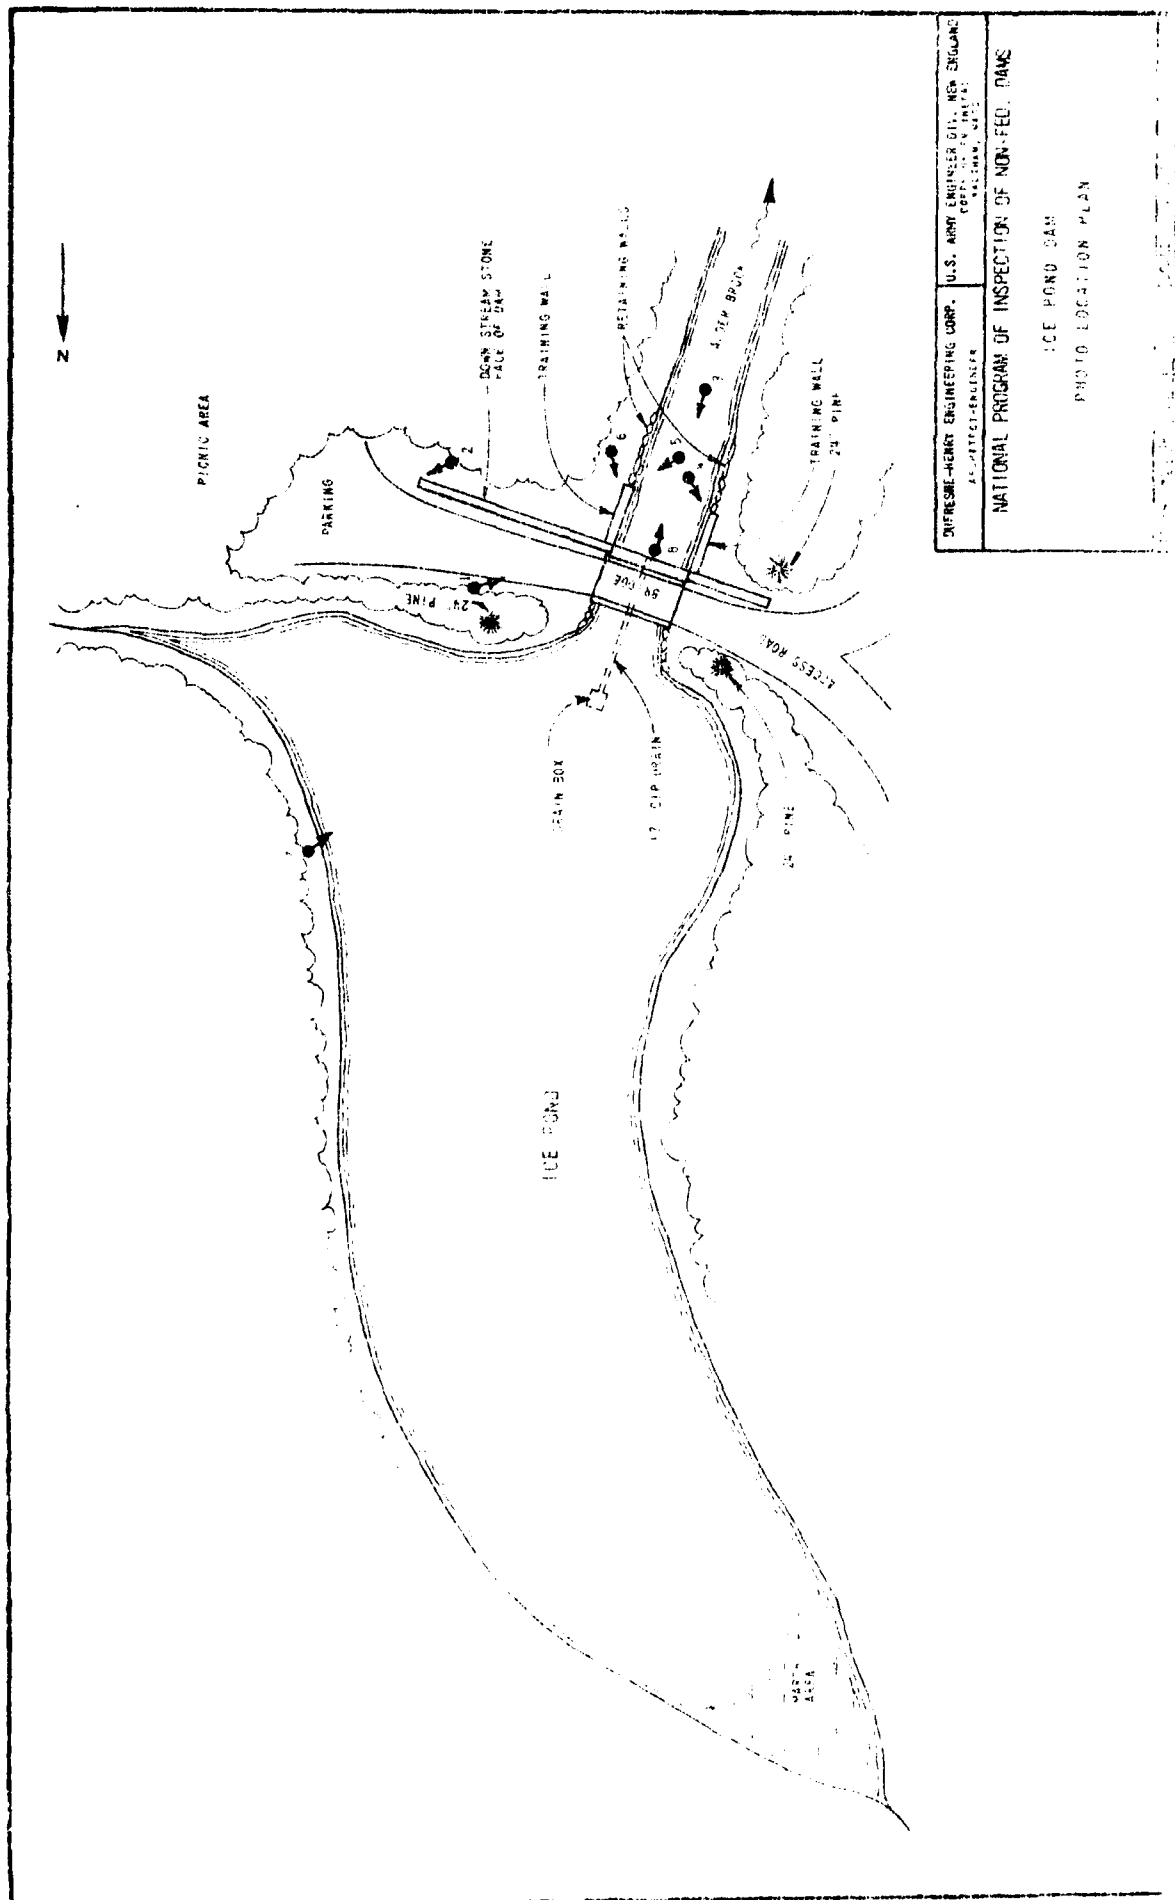
The downstream face of the dam is of stone masonry construction. The surface is irregular and shows no apparent seepage. There is some growth of vegetation out of cracks in the wall. At the left abutment there are some voids in the wall, and apparently some stones are missing (see Photo 2). The cause of the deterioration of the wall at the left abutment is probably erosion due to runoff from the access road. An inspection along the toe of the downstream wall revealed no indications of seepage. There are several trees growing immediately downstream of the dam.

left abutment where the stone wall contacts the abutment (see Photo 2). As noted in Section 3, some erosion has occurred in this area.

#2. VIEW OF EROSION AND SUPPLEMENT AT  
LEFT ABUTMENT

1. Reconstruct the spillway training walls.
2. Repair the downstream face of the dam.
3. Remove the flashboard pins in the spillway.
